SmartSignal Predictive Analytics – OSIsoft Anchorage Regional Seminar

**Nick Perkins – Solution
Architect – September 16, 2010**

Examples from BP Alaska

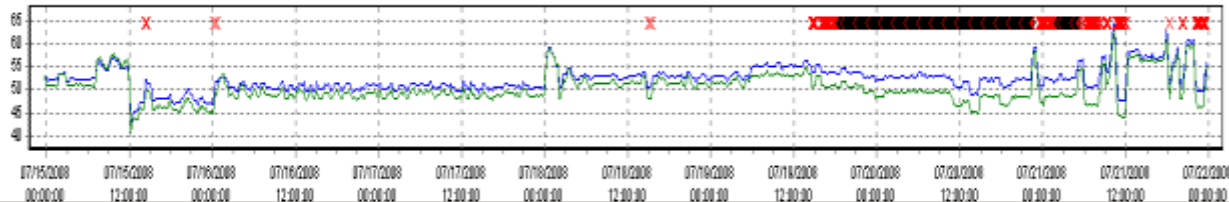
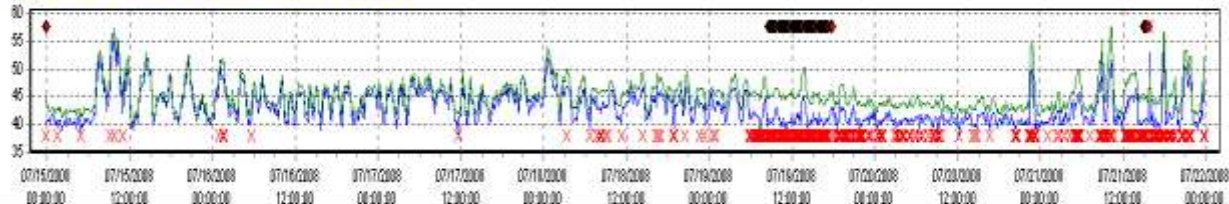
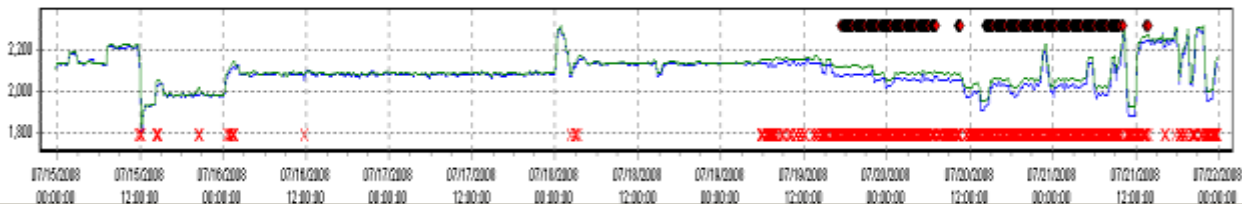
GC2 P7704B Pump – July 2008

➤ Pump operating at or near minimum flow, low discharge pressure and high speed

- Reliability Engineer started investigation with field Reliability Tech
- Believed there may be a problem with the pump bundle
- Upcoming S/D, so Overhaul ordered a complete pump bundle to have on standby
- On the scheduled S/D, 5 minute boroscope inspection revealed significant wear / damage
- Based on the condition of the bundle, it was changed out, minimized production impact

➤ Recommendation: Check field for filter plugging or obstructions.

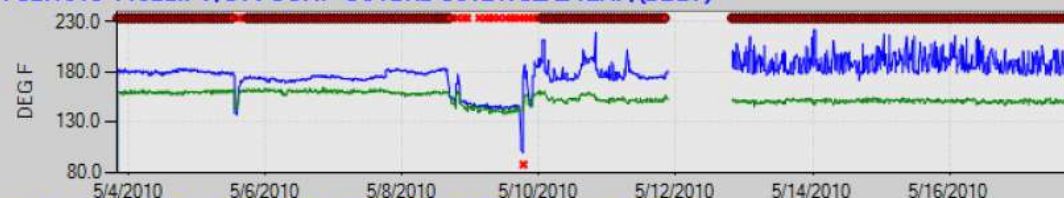
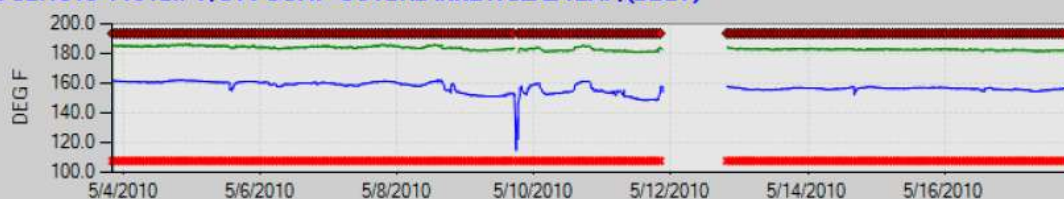
FS2
FS2 16-1802
Possible seal issue

Description:
Seal temperature spiking following a step change

Diagnosis:
Possible seal issue

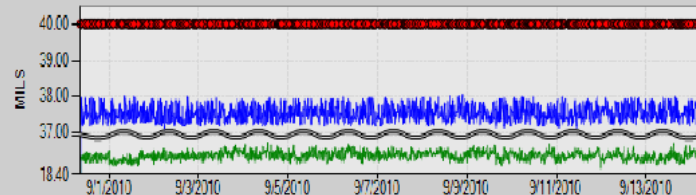
Report 579 -Update- Gen axial
position - positive residuals

Shifted back up to previous reading
Shift in position from 39 to 21 was moore card
changed is this the new condition

Possible moore card failure again
Bad or damaged instrument.

. It is likely that this issue is due to problems
with the Moore card system work order to
repair
What I get out of the email from John (vibe
tech) is that this may be a Moore card issue
that is causing the 39 mil axial reading on FS3
15188. Sounds like it should be reading about
8 mils.

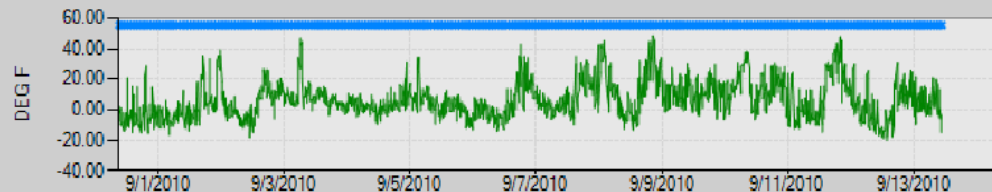
GC2
GC2 02-7000
Report 640-Update-
Ambient temperature - bad
sensor

Description:
The ambient temperature tag has
stopped retuning data

Diagnosis:
Sensor/data issue

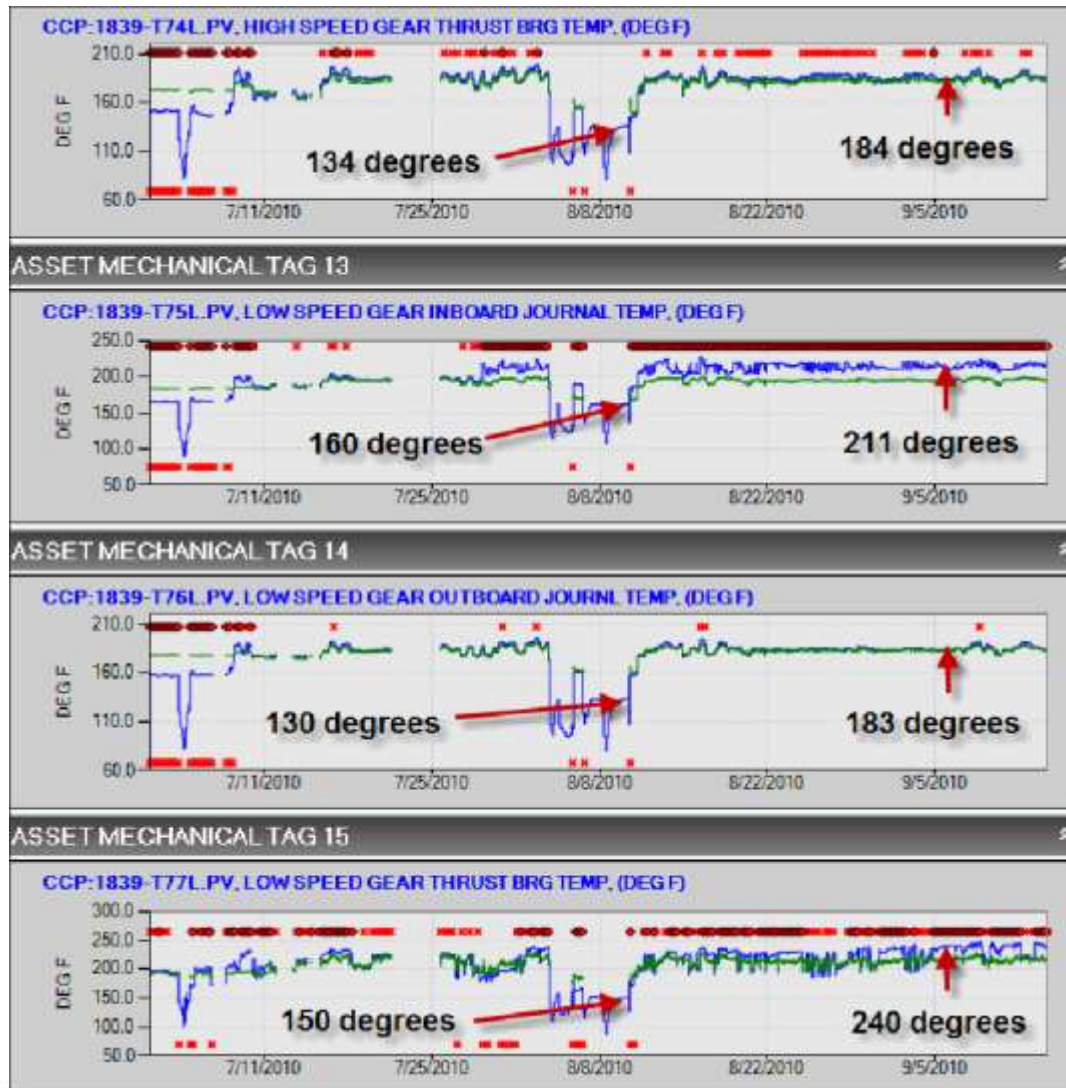
CCP 18-1810 (cont)

Up to a 40 degree spread across
bearings when machine is down
additional chart next slide We are
seeing the inboard journal bearing
temperature approximately 20 degF
above model predictions. We have
not seen an increase in the low
speed outboard journal temperature.

Data issue moore cards Possible bearing
issue
Possibly increase lube oil pressure

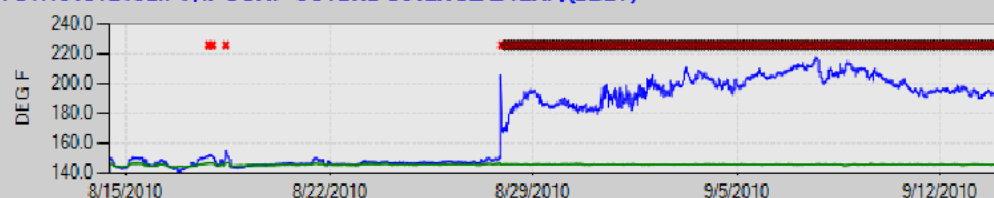
Report-685-Update-
Outboard outer seal
temperature - positive
residuals

Condition continues

On 8/27 the outer seal temperature increased from 148 degF to 194 degF with spike to 205. We did not see any changes in the outboard inner seal temperature, or other seal temperatures

Possible seal flush restriction or sensor issue

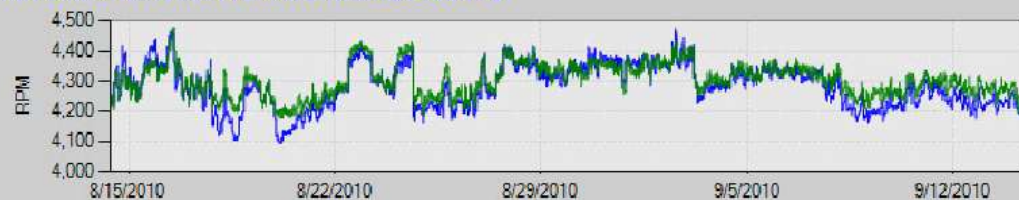
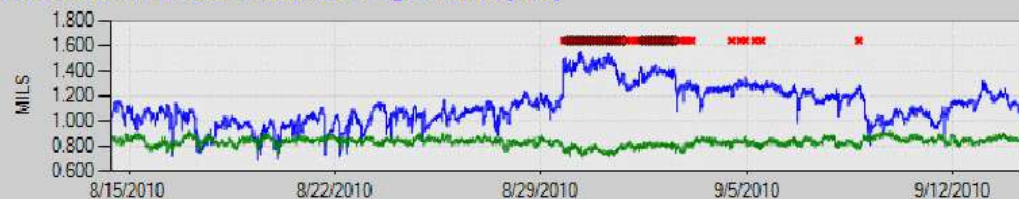
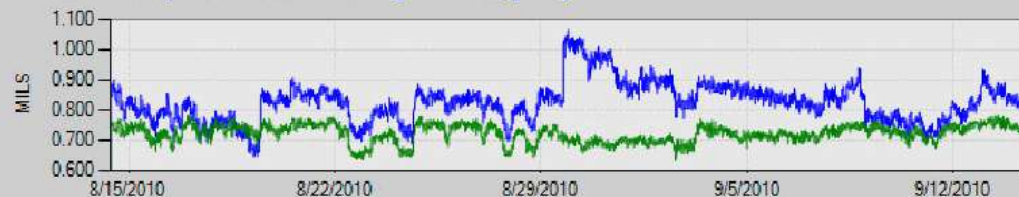
Report-Update-689-shaft 2
bearing vibrations

Condition has improved with
decreased speed
There is increased bearing vibrations
with constant turbine shaft speed
starting on 8/29.

Possible bearing issue

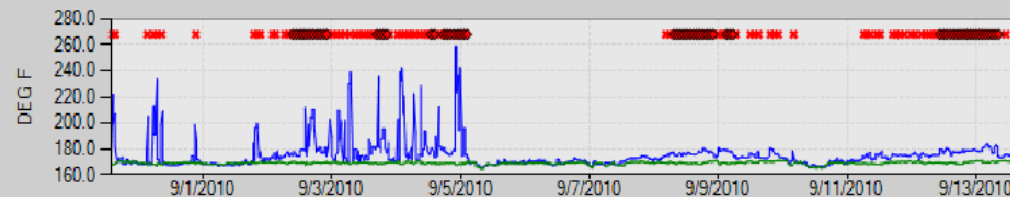
Report-700-Outboard
journal bearing temp
spiking

Temperature was spiking at this time it
has steading out possibly a conection
issue will add to sensor list

Sensor issue

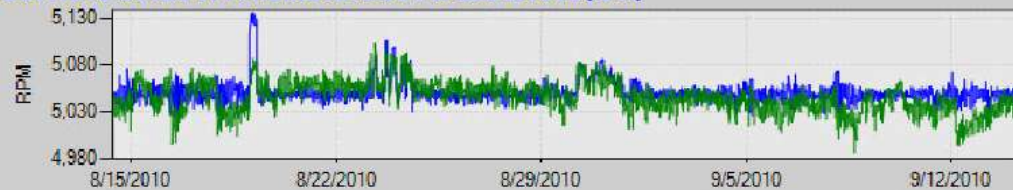
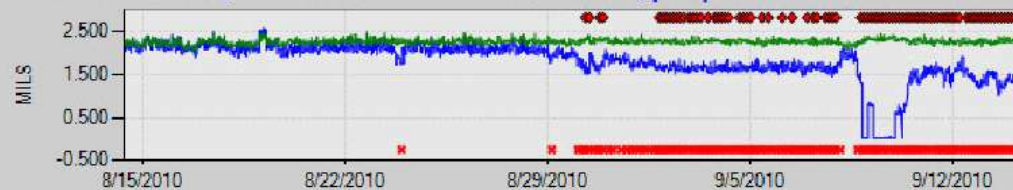
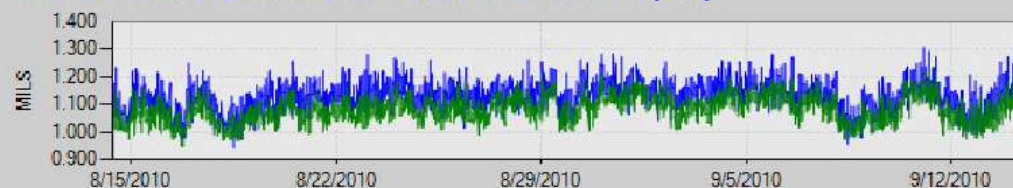
CCP
CCP 18-1803
Report-705-TURBINE
INBOARD HORIZONTAL
VIB - Low residuals

Description:
Since 8/29 inboard horizontal vibration reading has been shifted lower from tracking accurately around 2.3 Mils down to 1.4 Mils (on 9/14). It also appear that on 9/9 reading dropped down to 0.02 Mils.

Diagnosis:
Possible moore card issue
