# USERS CONFERENCE 2016

# Environmental Compliance at the Goldstrike Mine

Presented by **Ted Olsen-Tank**

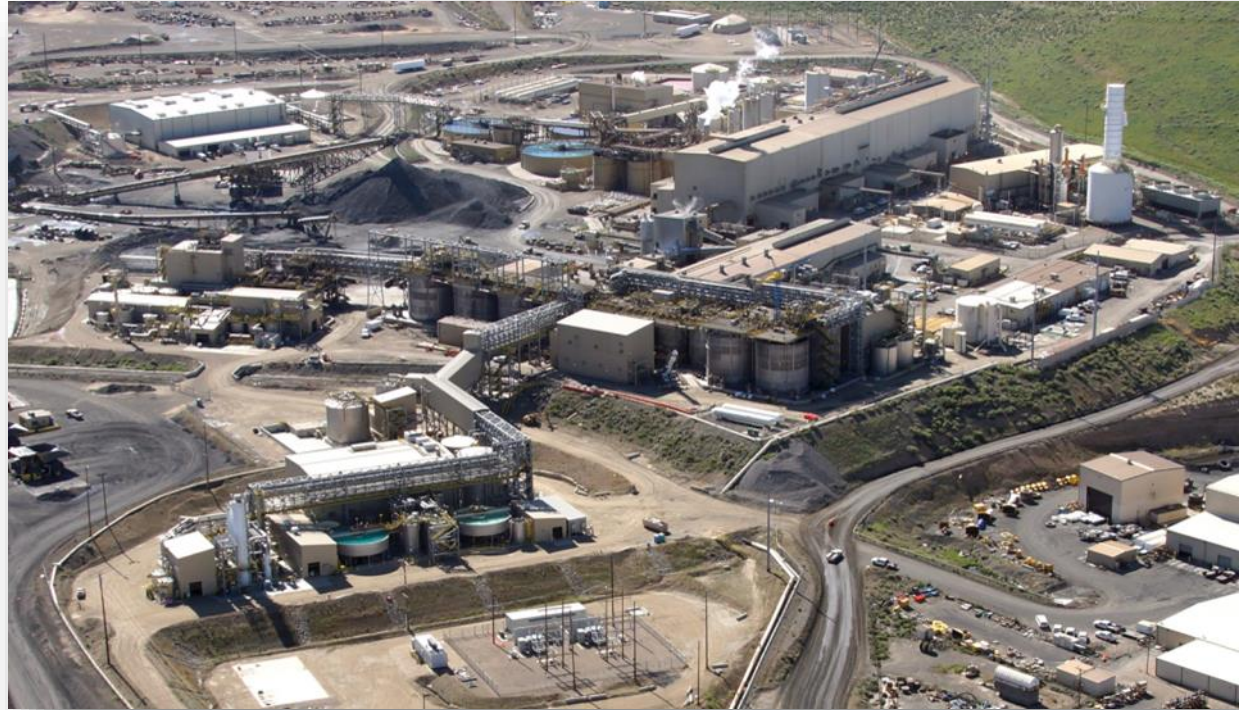
Large-Scale Capital Project

1200+ Contractors and 12+ cranes on site most times during construction

Construction completed November 2014

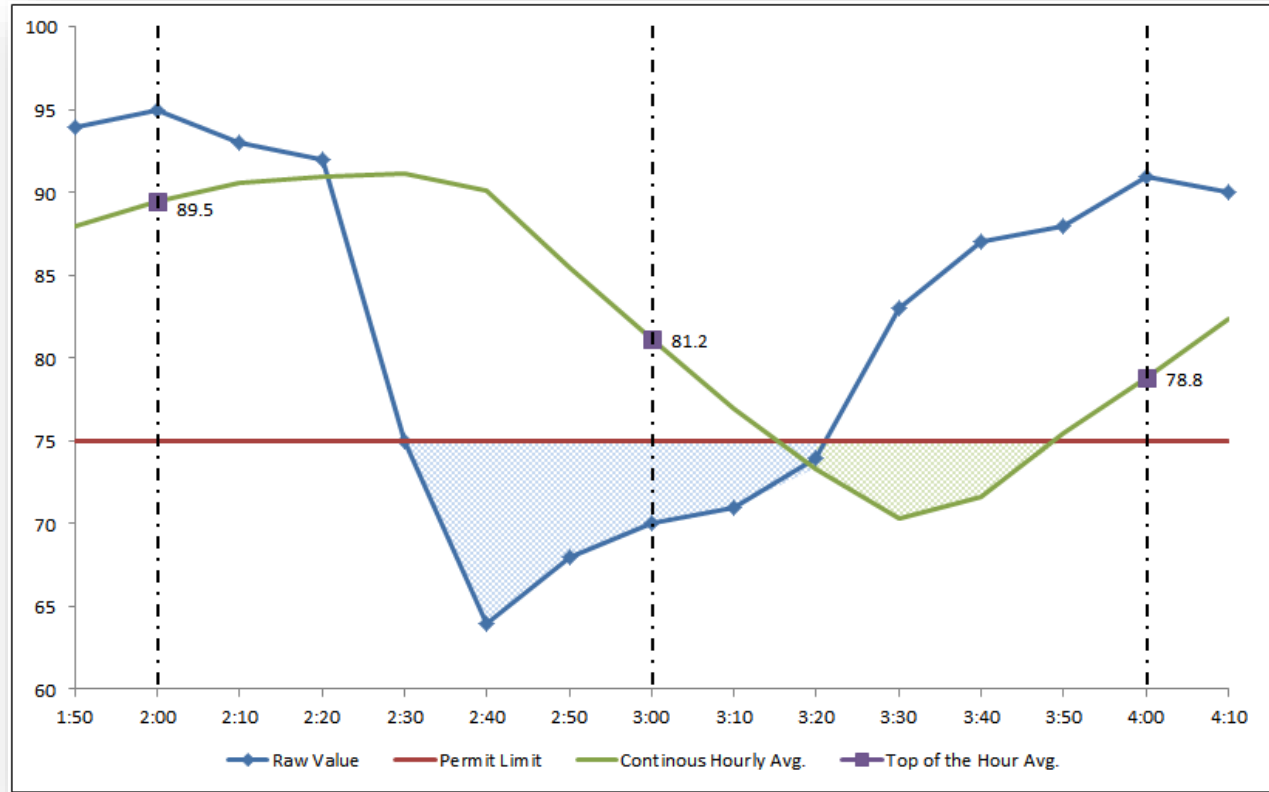
Permit requires  
hourly avg. on  
the top of every  
hour

PI System's  
Continuous  
monitoring is  
more accurate

Time	Hourly Avg.
2:00 PM	89.5
3:00 PM	81.2
4:00 PM	78.8

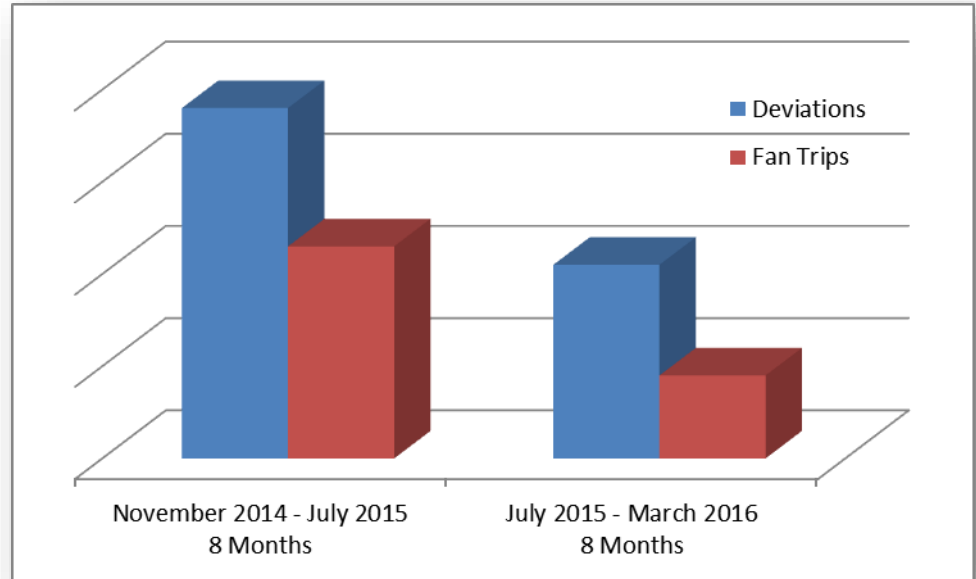
Comparing before to after AF implementation, the total number of Deviations decreased by **45%** and total Fan Trips decreased by **61%**

Deviations were identified immediately in real time

Feedback was given to operators and training sessions were facilitated
