# Value of Partnerships and Collaboration for World Class Performance Monitoring

Brianne LaBry  
Chevron Global Power

October 28, 2009

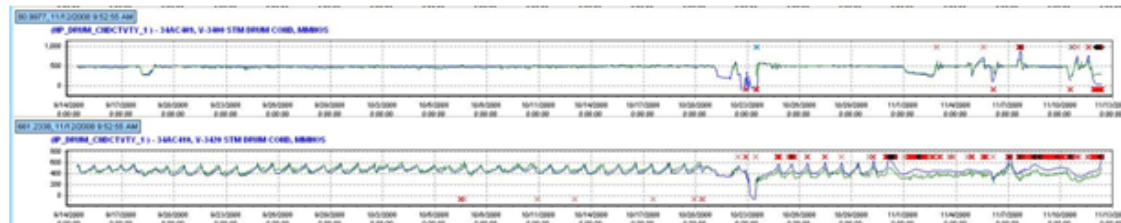
Starting on 10/24 we've seen slight changes in the conductivity readings, but nothing significant until 11/7 when HP DRUM CONDUCTIVITY (4AC409, V-3400 STM DRUM COND) spiked up to ~855 MMHOS. It seems like some corrective action was taken because this sensor is now reading ~30 MMHOS. However IP DRUM CONDUCTIVITY (34AC410, V-3420 ST DRUM COND) continues to increase, and today reached 661 MMHOS and seems like it is still going up. See the screenshots below

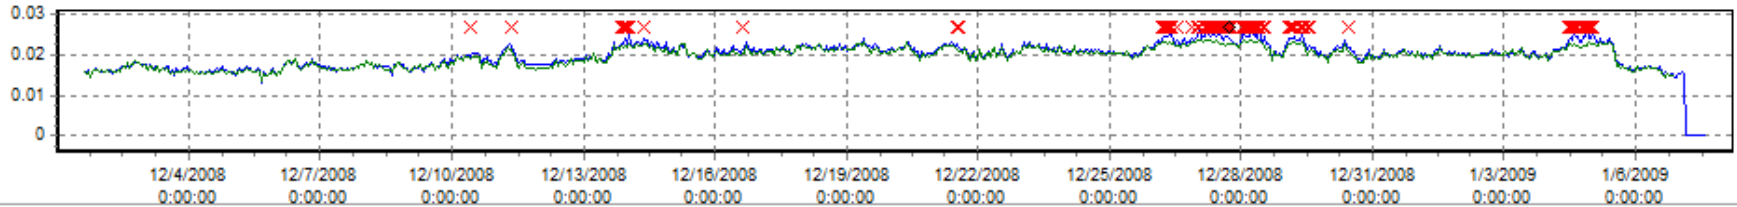
0.0167, 12/5/2008 10:46:25 AM

(NH3/AIR\_RATIO) - 36FFI610, V3610 NH3/AIR MOLE RATIO, RATIO

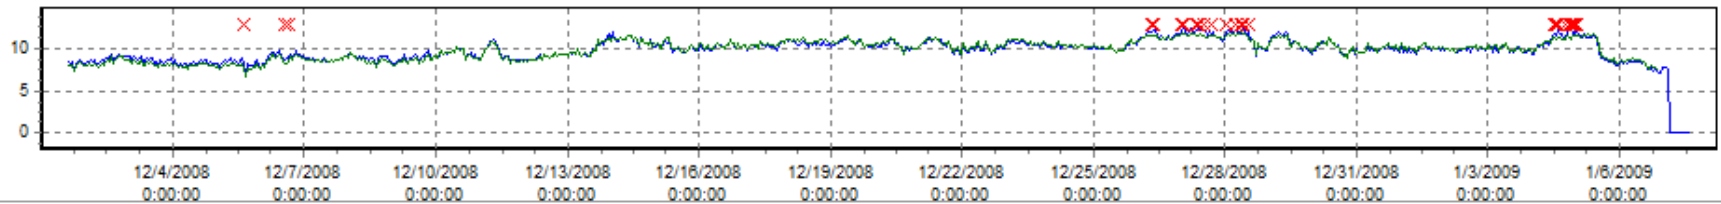
8.7177, 12/5/2008 10:46:25 AM

(NH3\_FLOW\_RATE) - 36FC610, AQ NH3 TO V3610, GPH

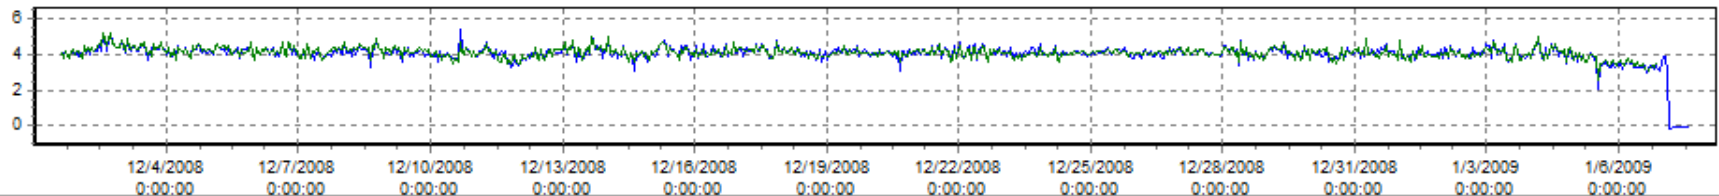
3.9749, 12/5/2008 1:46:25 PM

(STACK\_NOX) - 36AI648Y, HRSG STACK OUTLET NOX, PPM

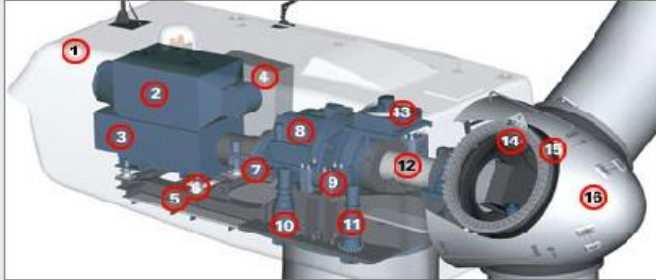
## Wind Turbine

- Nacelle
- Heat Exchanger
- Generator
- Control Panel
- Main Frame
- Impact Noise Insulation
- Hydraulic Parking Brake
- Gearbox
- Impact Noise Insulation
- Yaw Drive
- Yaw Drive
- Rotor Shaft
- Oil Cooler
- Pitch Drive
- Rotor Hub
- Nose Cone

Wind Deviation (1 sec)	0	Bearing A Temp.	0	Control Box Temp.	0
Wind Deviation (10 sec)	0	Bearing B Temp.	0	Control Box Axis 1 Temp.	0
Rotor Speed	0	Air Temp.	0	Control Box Axis 2 Temp.	0
Torque		Generator Cooling Air Temp.	0	Control Box Axis 3 Temp.	0
Blade 1	Set Value	Gearbox Bearing Temp.	0	BatteryBox Axis 1 Temp.	0
Blade 2	0	Drive Train Acceleration	0	BatteryBox Axis 2 Temp.	0
Blade 3	0	Hydraulic Pressure	0	BatteryBox Axis 3 Temp.	0
Trip Speed Rotation	0	Hub Temp	0	Voltage A_N	0
Generator 1 Temp.	0	Gearbox Temp.	0	Voltage B_N	0
Generator 2 Temp.	0	Current Phase A	0	Voltage C_N	0
		Current Phase B	0	Line Frequency	0
		Current Phase C	0	Placeholder	0
				Placeholder	0
