Chevron's Power Performance Monitoring Solution

Empowering Business in Real Time
PI Infrastructure for the Enterprise

El Segundo Refinery CHP Overview

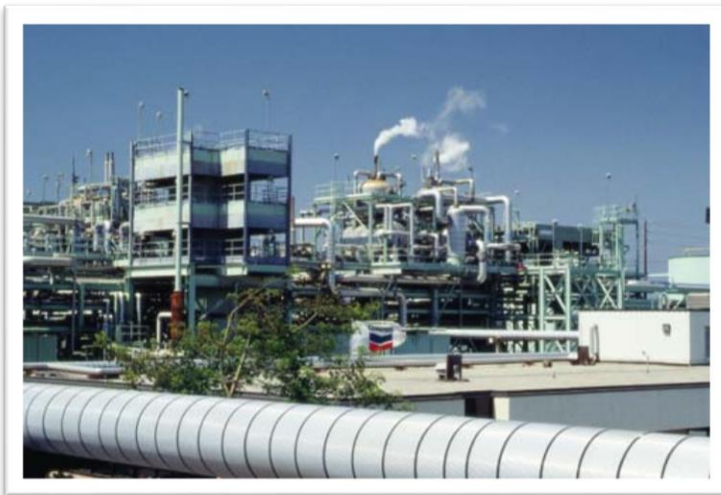
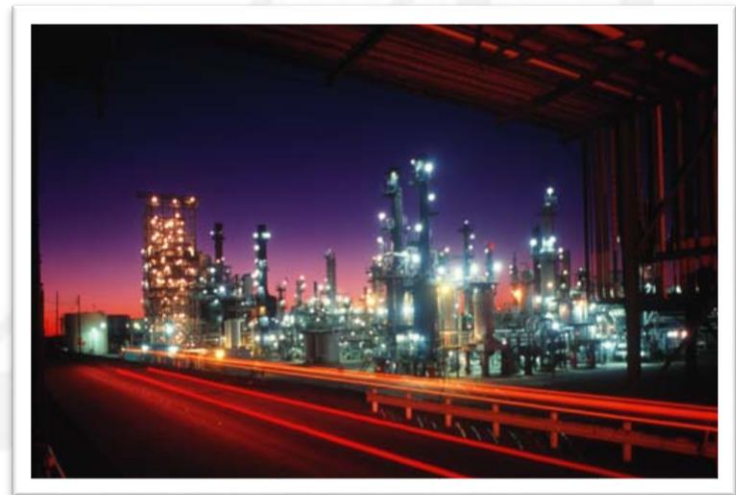
Located on the Pacific coast in El Segundo, CA just south of LAX.

- 3 - Cogeneration Trains (GE Frame 6Bs, dual pressure HRSGs), + 170,000 hrs.
- 1 - Steam Turbine Generator
- 1 - Auxiliary Boiler
- 2 - Sets of BFWPs

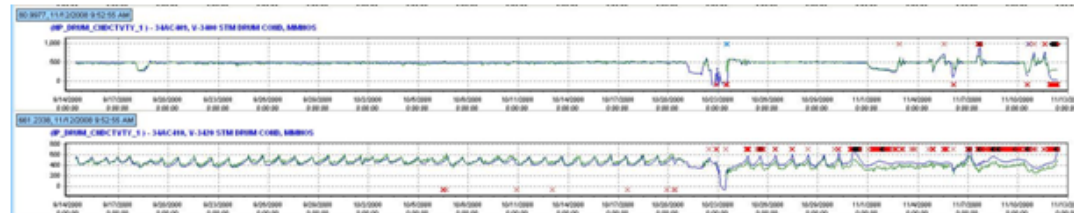
Starting on 10/24 we've seen slight changes in the conductivity readings, but nothing significant until 11/7 when HP DRUM CONDUCTIVITY (4AC409, V-3400 STM DRUM COND) spiked up to ~855 MMHOS. It seems like some corrective action was taken because this sensor is now reading ~30 MMHOS. However IP DRUM CONDUCTIVITY (34AC410, V-3420 ST DRUM COND) continues to increase, and today reached 661 MMHOS and seems like it is still going up. See the screenshots below

Comment	Starting on 10/24 we've seen slight changes in the conductivity readings, but nothing significant until 11/7 when HP DRUM CONDUCTIVITY (4AC409, V-3400 STM DRUM COND) spiked up to ~855 MMHOS. It seems like some corrective action was taken because this sensor is now reading ~30 MMHOS. However IP DRUM CONDUCTIVITY (34AC410, V-3420 ST DRUM COND) continues to increase, and today reached 661 MMHOS and seems like it is still going up. See the screenshot attached

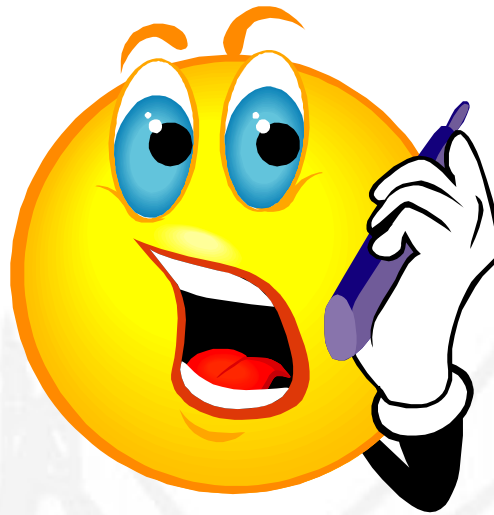
11/7/2008: PSC received phone call from SmartSignal APC informing of a NH3/air ratio High Rule posting on the WatchList.

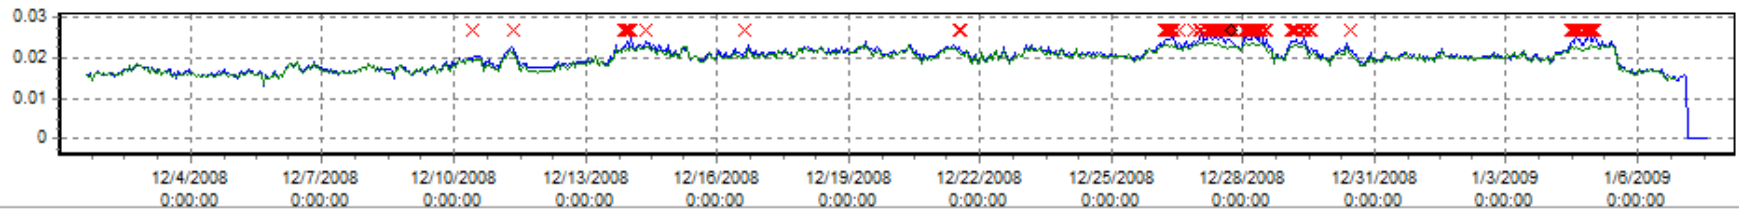
(NH3/AIR_RATIO) - 36FFI610, V3610 NH3/AIR MOLE RATIO, RATIO

0.0167, 12/5/2008 10:46:25 AM

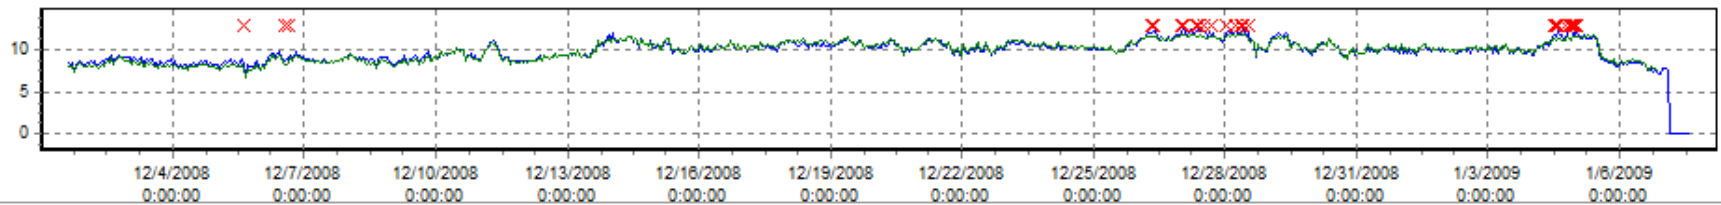
(NH3_FLOW_RATE) - 36FC610, AQ NH3 TO V3610, GPH

8.7177, 12/5/2008 10:46:25 AM

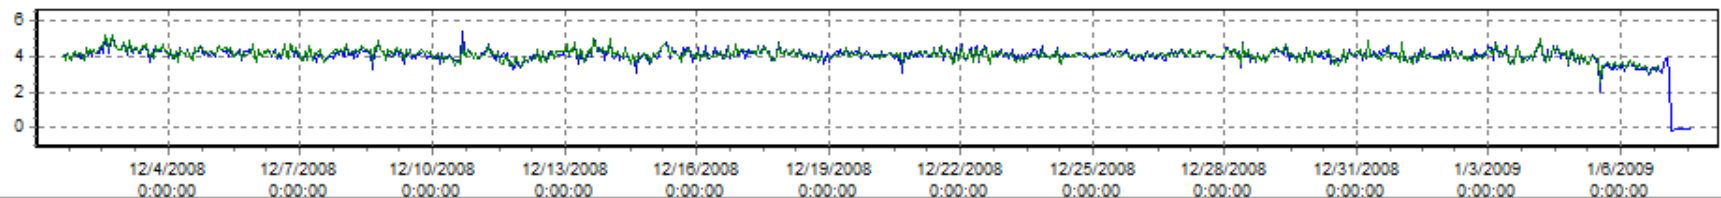
(STACK_NOX) - 36AI648Y, HRSG STACK OUTLET NOX, PPM

3.9749, 12/5/2008 1:46:25 PM

Equipment Integrity Review Log										
#	Exception Active/Closed	Report Date	Date Occurred	Train	Responsible Party	Trend	Tag	Tag Descriptor	Exception: Update: Emergent Item:	Action Taken:
88	Closed	1/7/2008	1/7/2008	C	RB	SS	36FC610	AQ NH3 to V3610	Monitor: NH3 Injection appears to be increasing without a correlation in catalyst efficiency.	Will notify site during weekly meeting.

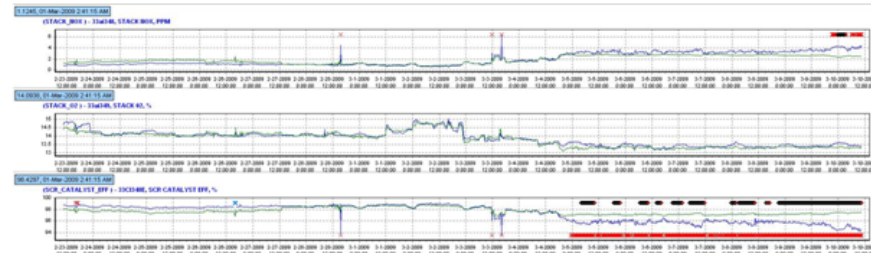
Roy, we noticed this morning that the efficiency of the catalyst on the E-3300 is declining rather precipitously. Here is a screen shot. It is only down about 4% but it does not appear to be turning. I have included the NOX as well since it is trending up and away from the estimate. I have made SmartTracking entries on these as well.

It looks like A Trn NOx is creeping up. There is no step change so it doesn't look like an operator set-point change.
