SmartSignal in Wind Power Generation

OSI User's Conference
Renewables Day
April 26, 2010

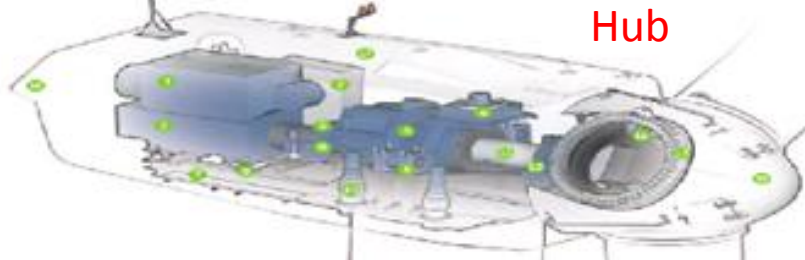
Generator

Gearbox

Hub

Personalized Empirical Models

Pulls every 5-10 minutes

EPI*Center

Posts Emerging Threats
to Incident List

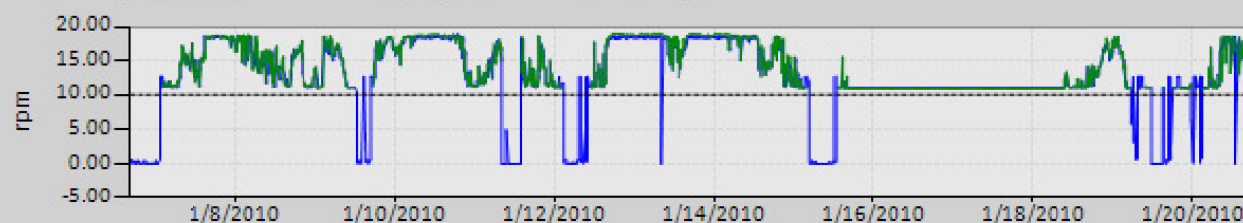
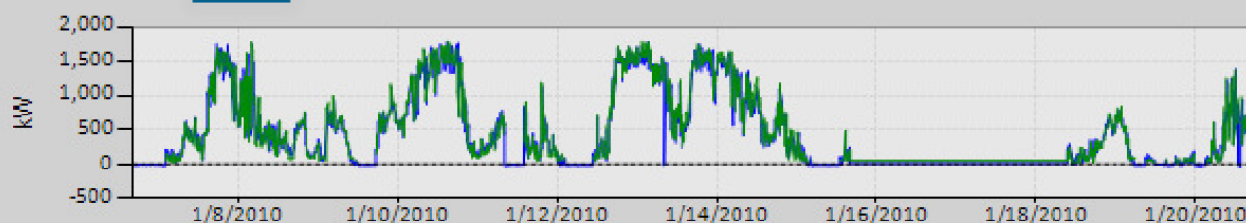
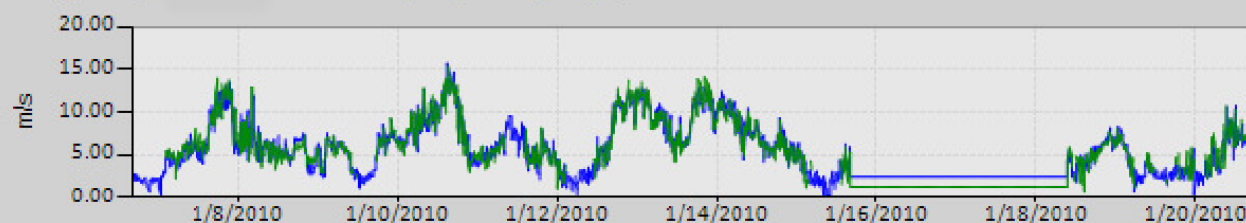
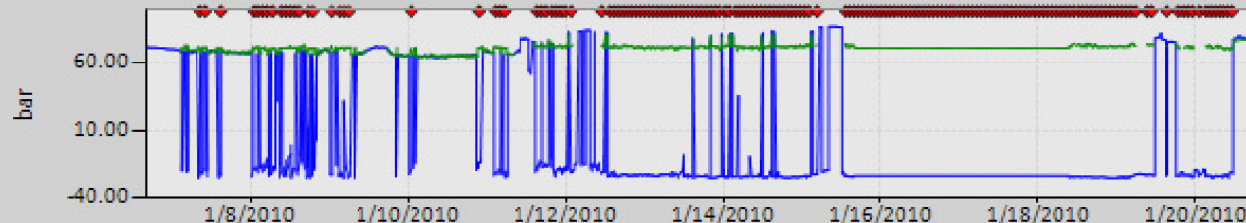
Turbine_18

We are starting to see the actual value for the hydraulic prepressure spikes from 67 bar to 0 bar. Is this possible a sensor issue?

Found brake handle hitting shield of pressure transducer and it was loose. Should be resolved as of yesterday ~2pm. Tracking better now. SSC will close report.

Hydraulic Brake Pressure signal drops to zero value since about NOV 20,

(HUB_SPEED) - Turbines.18.N_ROT_PLG, Rotor speed (PLC), rpm

(ACTIVE_POWER) - Turbines.18.P_ACT, Power, kW

(WIND_SPEED) - Turbines.18.V_WIN, Wind speed, m/s

(BLADE_HYDRAULIC_PRESS) - Turbines.18.HYD_PRES, Hydraulic prepressure, bar
