How PI Played a Key Role in Achieving Maximum Equipment Reliability

Presented by: Vlad Djuric
March 11, 2002
OSIsoft Users Conference

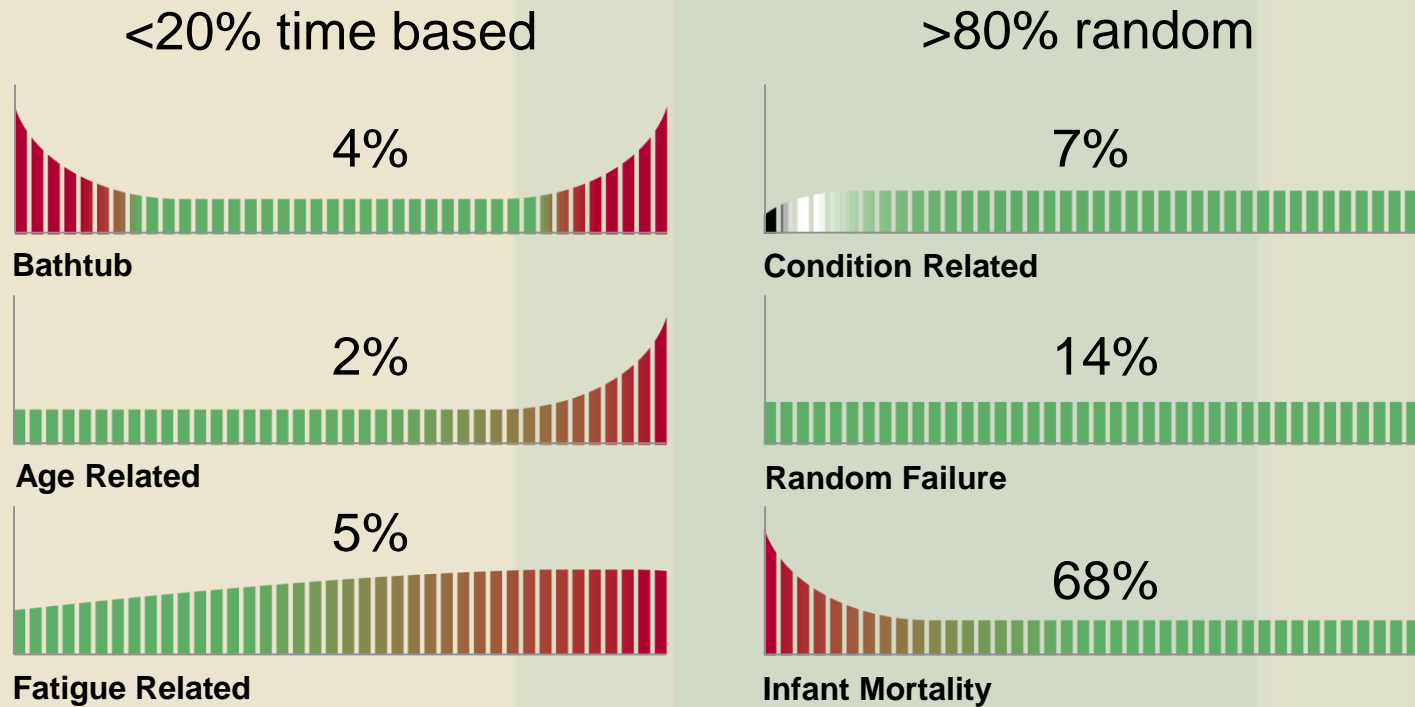
- There are six failure patterns

The majority of failures are random, not time-based

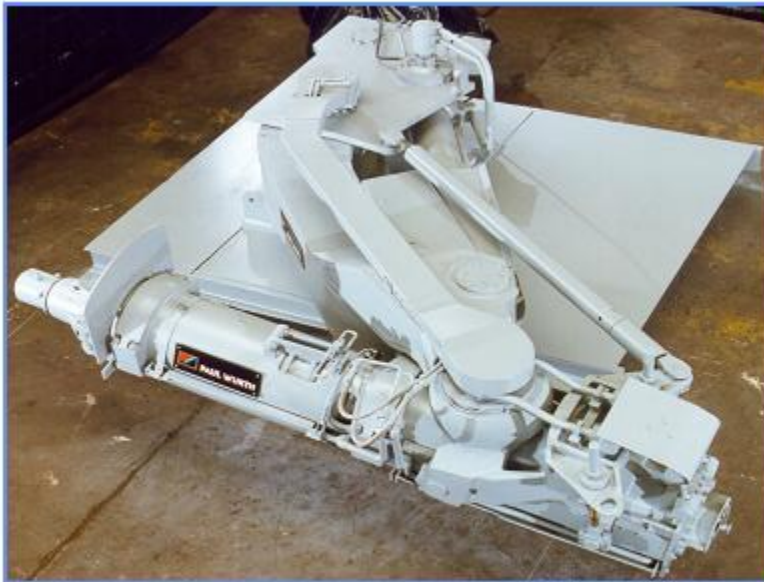
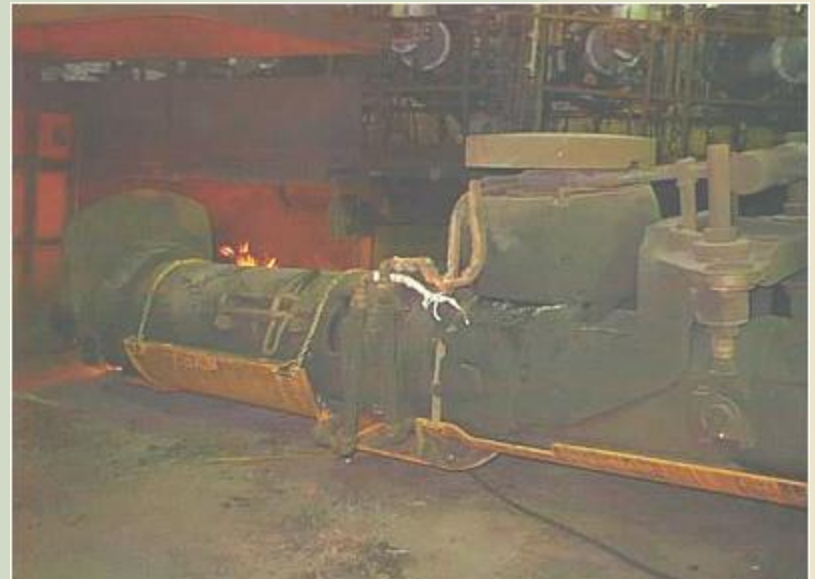
RCM Information Worksheet - [THFSWING]

Asset: Tap Hole / Swing Cylinder System

Functional Failure	Failure Mode	SA	Failure Effect
1	Swing Cylinder fails to properly position mudgun cylinder over taphole.	1 Furnace tap hole face builds up during casting.		Once the furnace taphole has been drilled, molten iron is released to atmosphere, and pours into the trough runner system. As the molten iron is released, it sprays over the existing equipment
2		2 Furnace tap hole erodes during normal use.		During normal furnace operation, and when the furnace is tapped, the flow of molten iron travels over the tap hole refractory. Over time, the tap hole refractory lining erodes, and follows same as
3		3 Swing Cylinder hydraulic system fails.		To be analyzed separately.
4		4 Swing Cylinder extend cylinder limit fouls.		Over time, the release of molten iron spray from the furnace tap hole, settles on the Swing Cylinder extend limit, and eventually melts the limit switch. next Swing Cylinder sequence,

An RCM analysis was done to identify the maintenance program for this asset

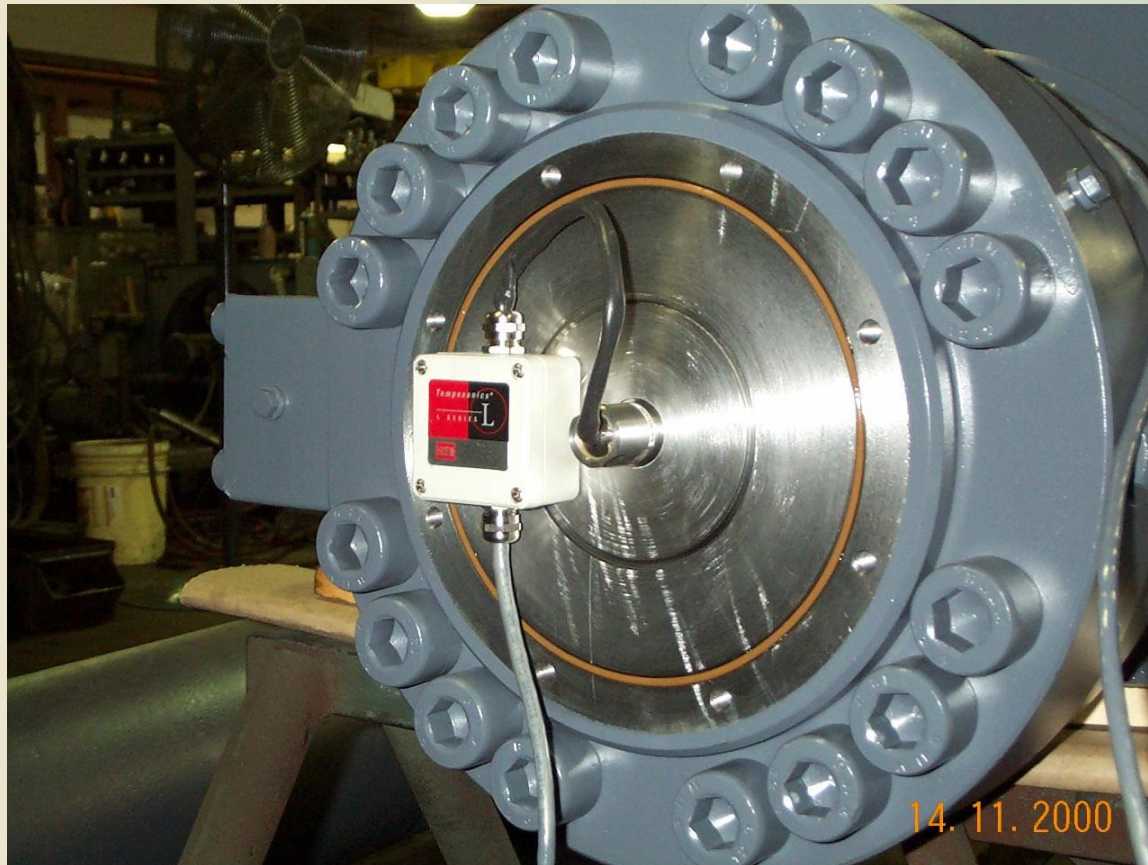
Swing Cylinder with LVDT

- Installed Linear Voltage Differential Transducer (LVDT) into the end of the Swing Cylinder
- Calibrated the LVDT to Tap Hole Face based on a cylinder stroke of 1370mm
- Maintenance and Operations determined the effective stroke ranges of the cylinder required by the process

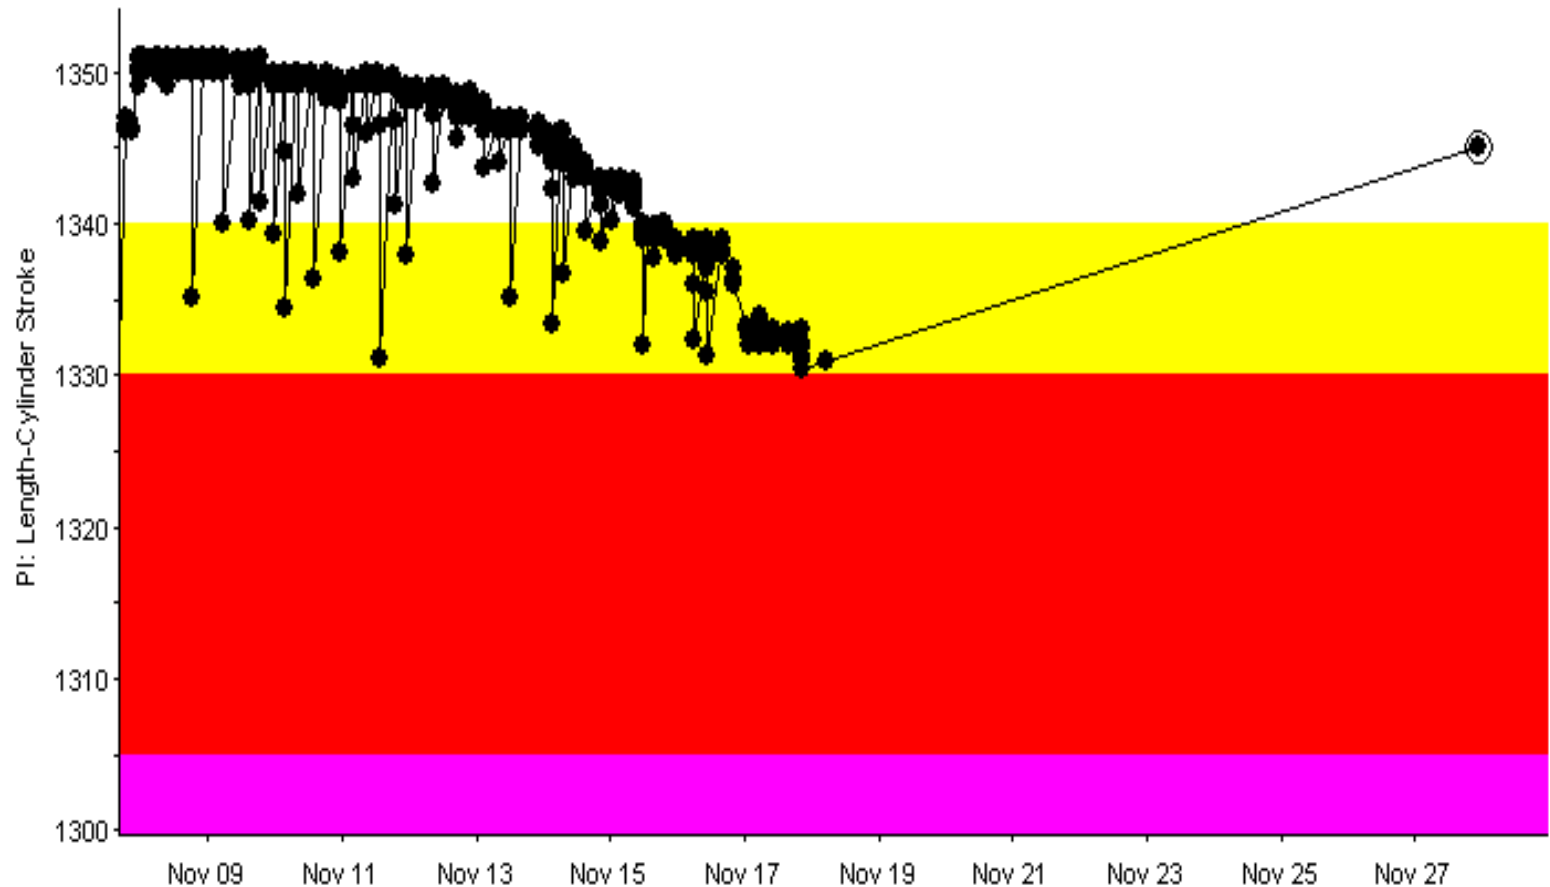
Graph - BAYN.PROC.IRON.BF4.CAST.GUDR.EGUN.SWIN.CYL: PI: Length-Cylinder Stroke vs Date

We can visually see how mudgun nozzle to tap hole face fit has deteriorated into alarm

The stroke of the Swing Cylinder has gone into alarm relative to the pre-determined levels identified when the maintenance program was set up.

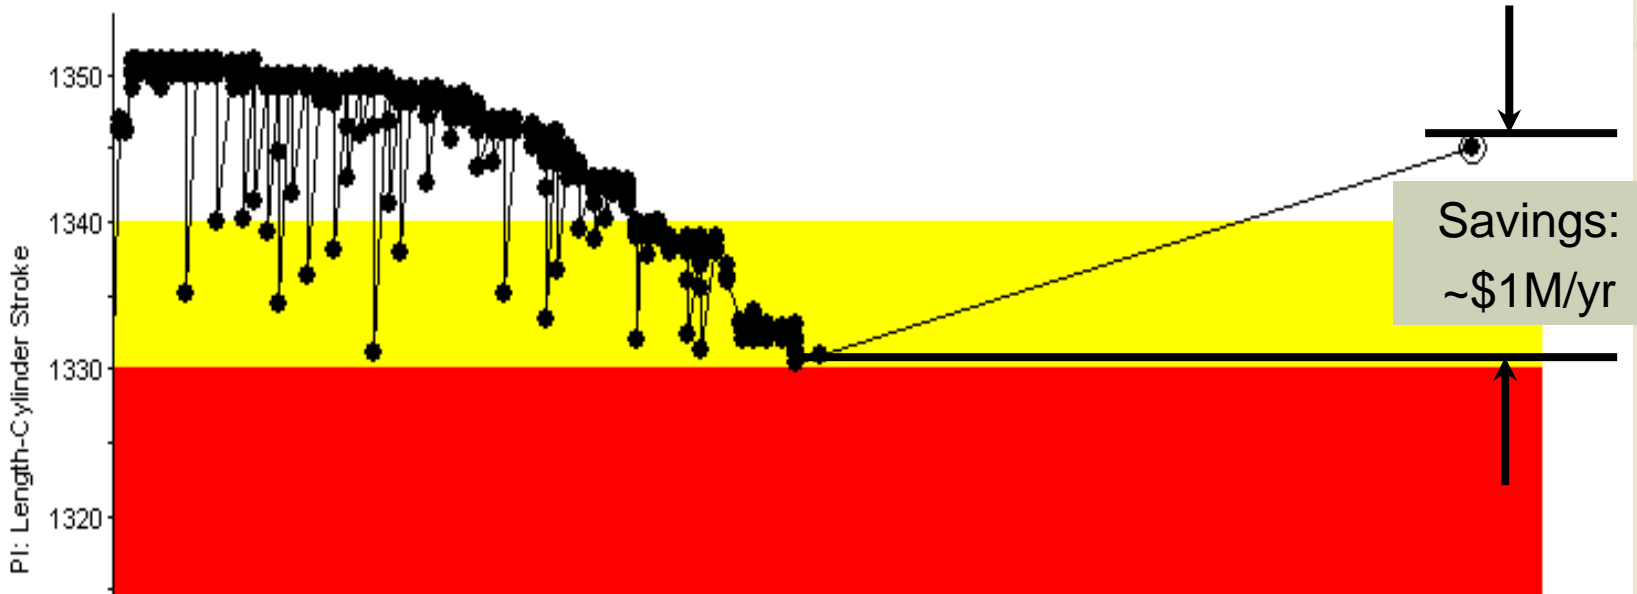
Graph - BAYN.PROC.IRON.BF4.CAST.GUDR.EGUN.SWIN.CYL: PI: Length-Cylinder Stroke vs Date

The work initiated by Dofasco's ICMS system, with the help of the PI Interface, resulted in a complete recovery of mudgun nozzle to tap hole fit, saving the company \$1 million per year, for every year the furnace operates past an 8 year campaign. The poor fit between the mudgun nozzle to tap hole, would not have been evident or remedied by the operators, based on existing control room data.
